2.0 Site Operations and Maintenance

2.1 Annual Site Inspection

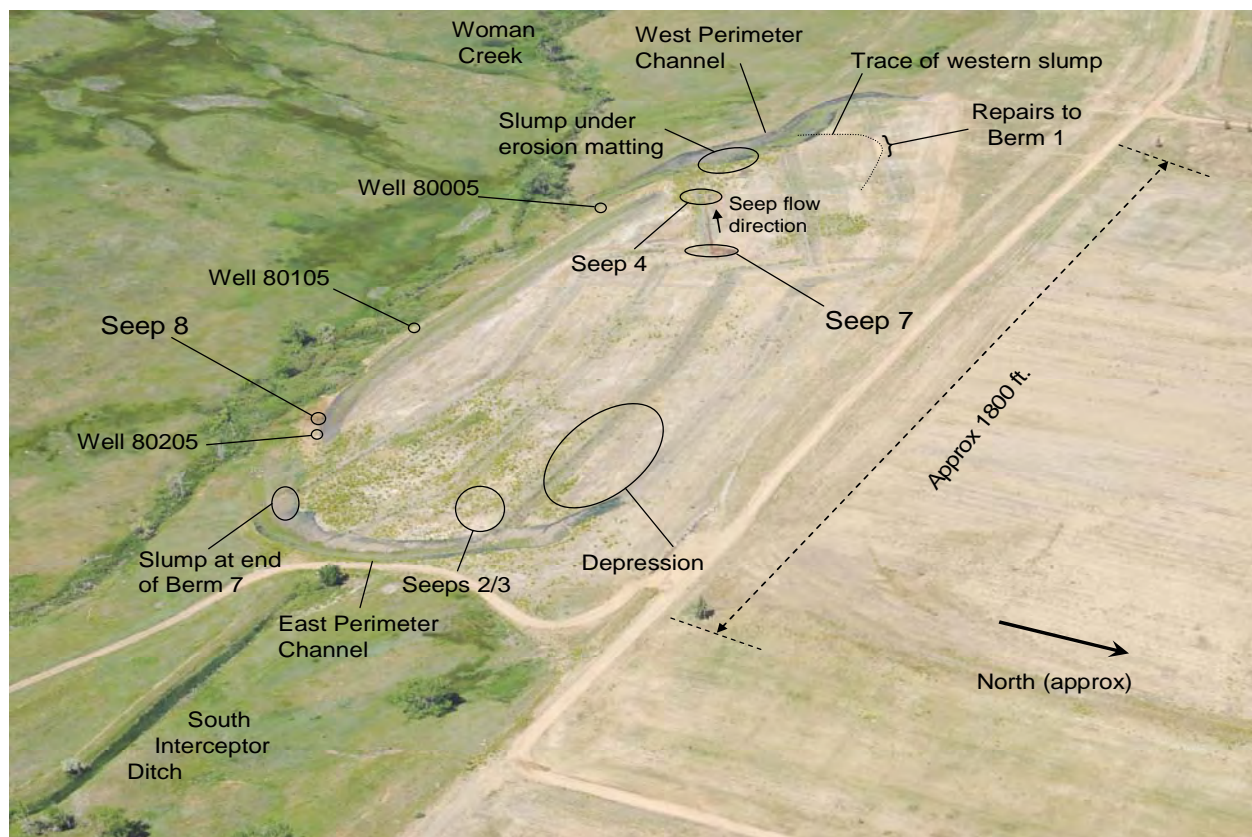
Figure 2-1. Aerial Photograph of OLF Taken June 2007

Conditions that warranted repair and that triggered further investigation were found at the OLF during 2007 inspections, as discussed below. Figure 2-1 is an aerial photograph of the OLF taken in June 2007 that illustrates the locations of the observed conditions.
